NASA CR-2166

FAILURE ANALYSIS OF  
ALUMINUM ALLOY COMPONENTS

*by Om Johari, Irene Corvin, and Joseph Staschke*

*Prepared by*  
IIT RESEARCH INSTITUTE  
Chicago, Ill. 60616  
*for Langley Research Center*

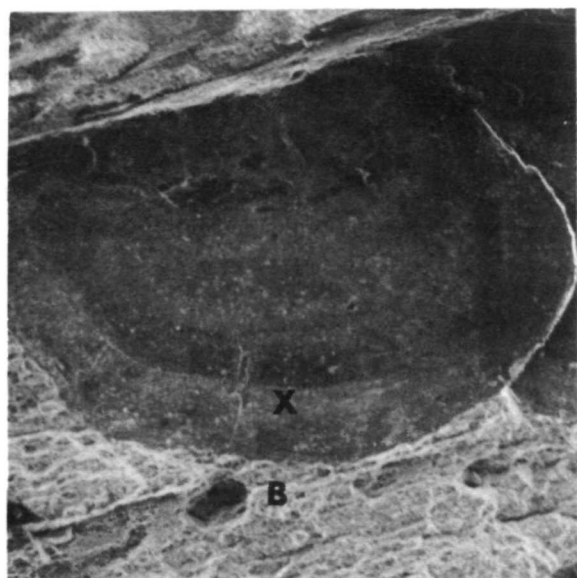
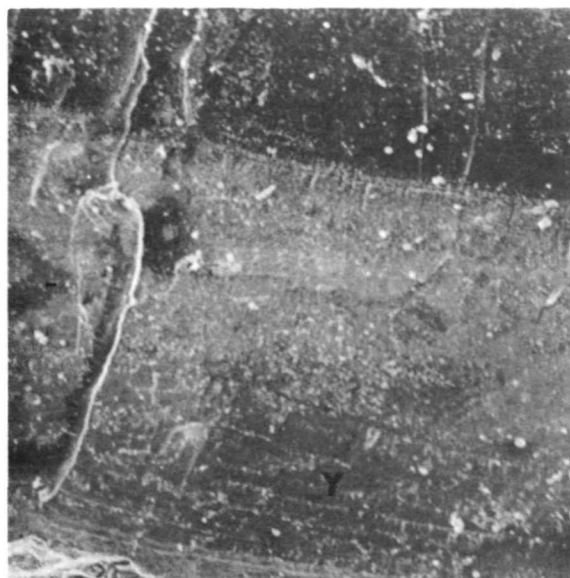
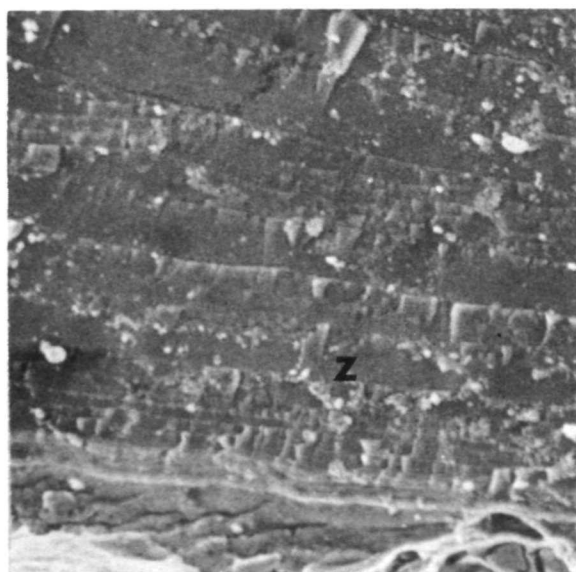
## Figure 2

Once the cracks initiated, the propagation was predominantly due to fatigue, since the areas which were farthest from the origins were relatively clean (in particular see the clear striations on the left of Figs. 2d and 3c). However, corrosion of the already fractured surface continued (e.g., see right of Fig. 3d), though the rate of attack was slower at the areas farthest from the initiation points. The specific nature of the corrosive environment cannot be inferred from knowledge only of the presence of Fe, Si, and Ca on the cracked surface.

Low-magnification view of area.

Area X of Fig. 2a.

Area Y of Fig. 2b.

Area Z, showing fatigue features and corrosion products.

SEM Fractographs of Area 1 in Fig. 1c.

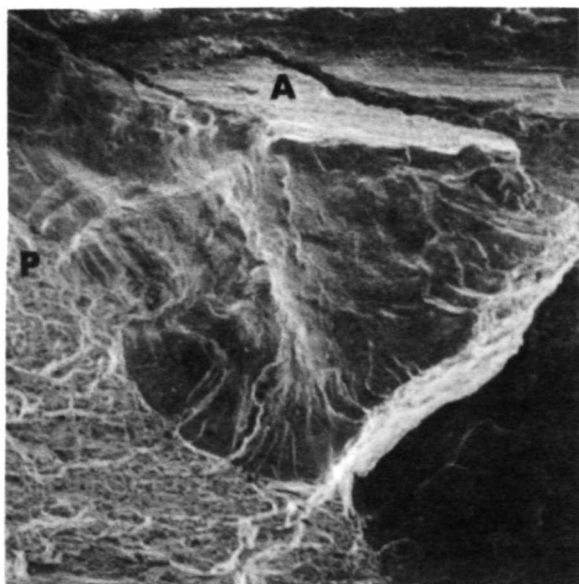
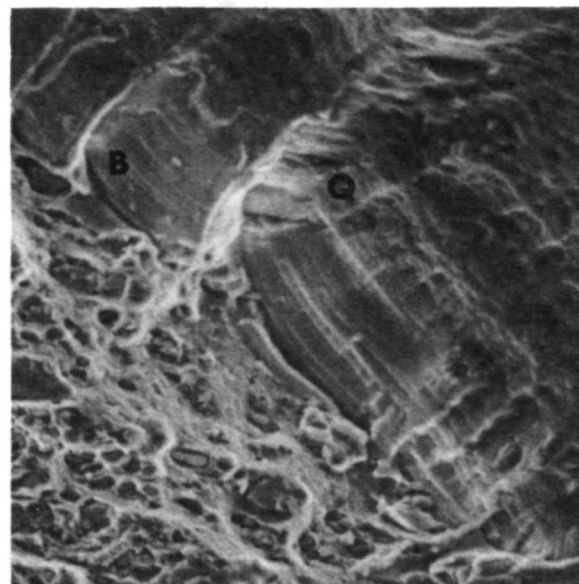
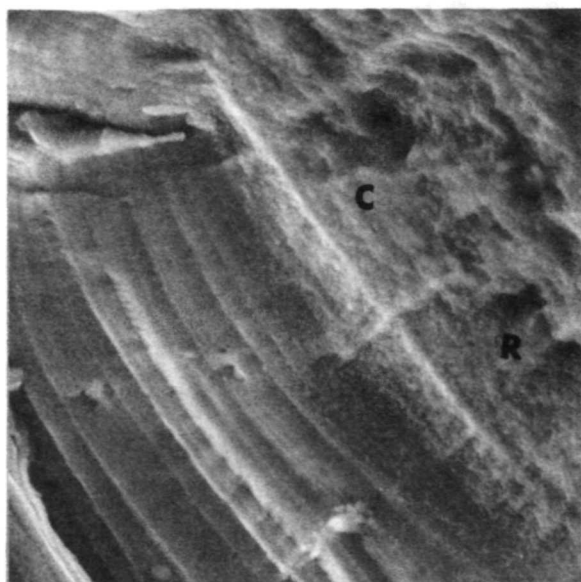
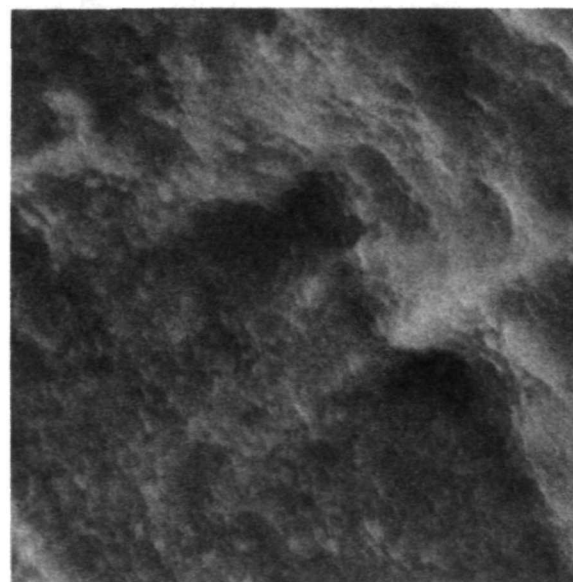
### Figure 3

SEM Fractographs of Area 2 in Fig. 1c, Showing Fatigue Features and Corrosion Attack.

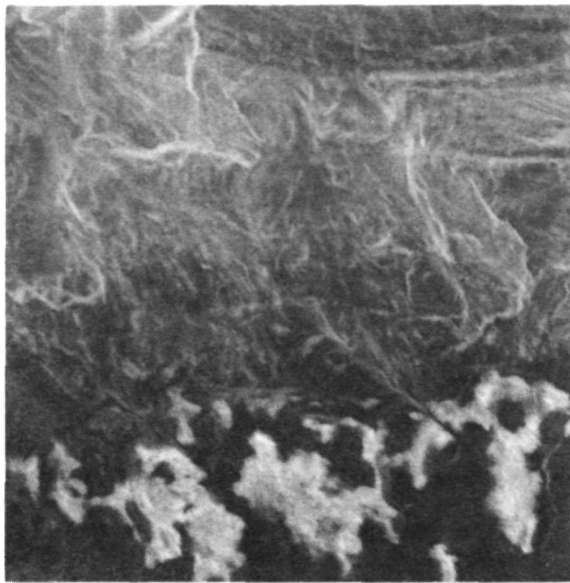
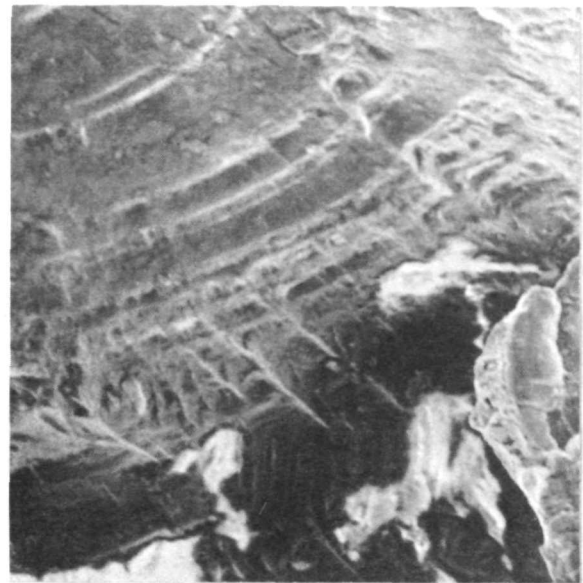
Figure 4

X-ray examination of the brownish debris (e.g., brightness in Fig. 4) indicated the presence of Si, Fe, and Ca in addition to Al (Fig. 5). The presence of these elements was repeatedly noted though their intensities varied from area to area. Thus, in the left part of Fig. 5, Fe is predominant, followed by lesser amounts of Ca and Al-Si (these elements are not resolved when simultaneously present). In the right part of Fig. 5 the Fe and Al-Si peaks were of about the same intensity in another area. The residue thus appears to consist of complex silicates of Fe, Ca, and Al.

SEM Photographs of Initiation Region of Another Crack. Very bright areas are brownish debris visible under optical microscope.

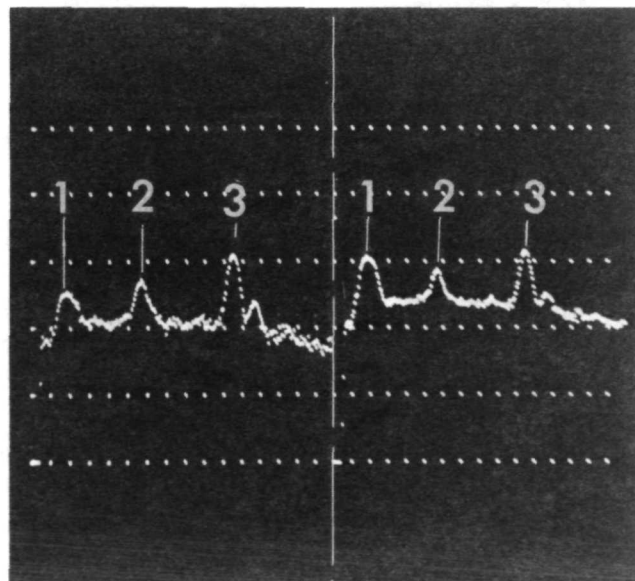
Figure 5

X-Ray Analysis of Two of the Debris Areas. Peaks in both patterns from left to right are (1) mixture of Al and Si, (2) Ca, and (3) Fe.

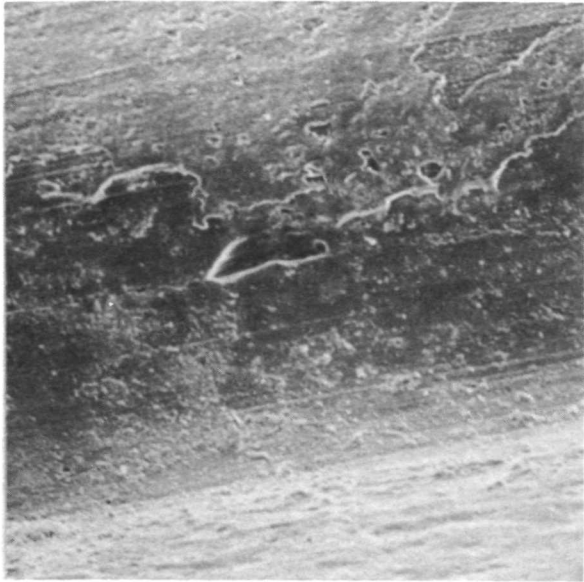
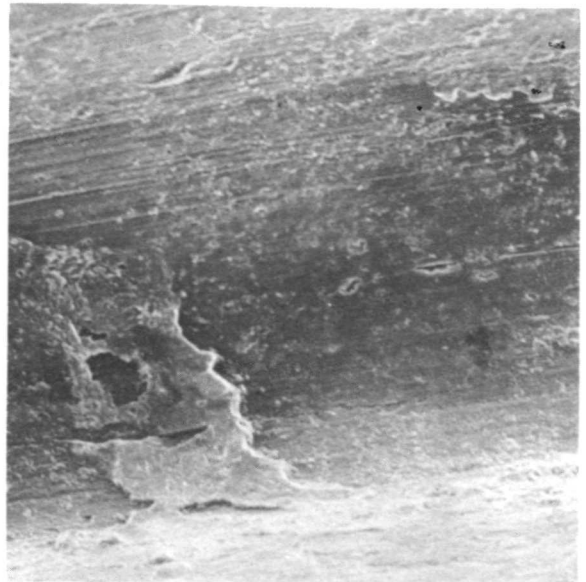
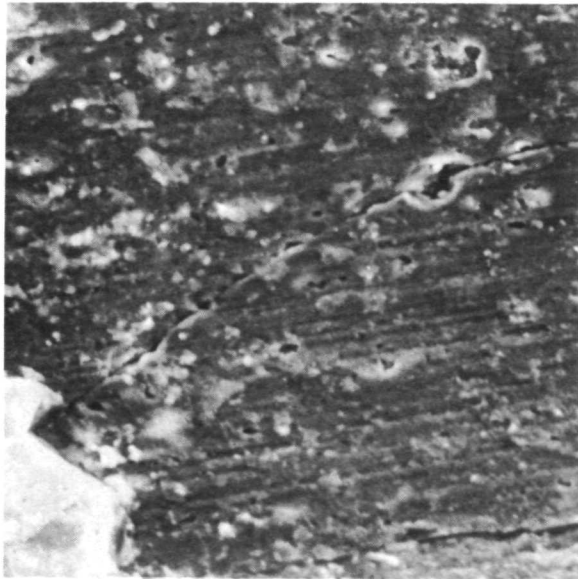
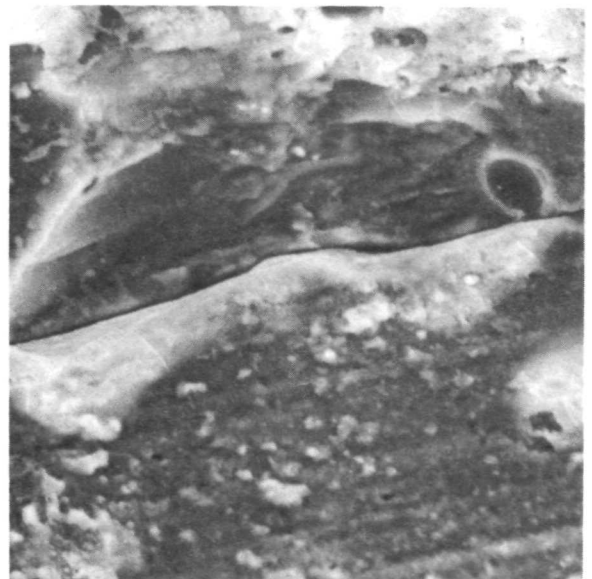
Region at left of Fig. 6a,  
indicating continuation of  
crack.

Center of Fig. 6a.
